# There 's a Triumph on my Stoep

(Rebuild 1955 Triumph TR2 TS 6766 - O)

David Patten  
March 2007

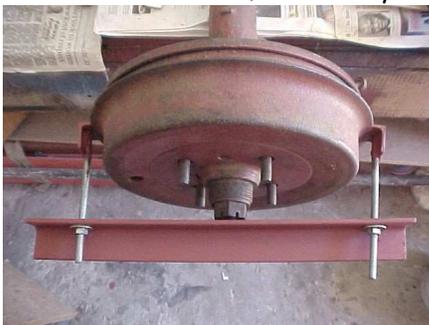
I first set about removing the brake drums that with the exception of the left rear came off without undue effort. However the left rear would not budge despite a little persuasion with a 10 lb hammer, which only resulted in my breaking a small piece away from the outer lip.

A close inspection revealed that the left rear drum had rusted tightly on the center cone preventing its easy removal. The right rear drum had cracks between the stud holes and the left front also had a piece broken out of the outer lip, similar to the damage I inflicted on the left rear. All four drums were taken for reconditioning resulting in 23 metal stitches to the right rear and brazing infill on the damage to the outer lips of the left front and rear drums. New bonded linings were fitted to the brake shoes though fortunately the drums did not require skimming. The linings were supposedly fitted to the profile of the drums though on later assembly one would never have believed it as they had to be filed in order to fit the drums.

The brake hydraulics were stripped and it was found that every cylinder was rusted solid. This resulted in all six cylinders having to be reconditioned with stainless steel sleeves. Fortunately the brake pistons were not badly corroded and could be reused. The lesson learned here is not to try and remove a stuck piston from the cylinder no matter how great the temptation, as the locating cap for the brake shoe is very flimsy and breaks away from top of the piston easily. The pistons were however removed from the cylinders by the specialists without difficulty, using compressed air. Similarly the clutch slave cylinder and brake and clutch master cylinder also required re-sleeving with stainless steel. Inspection of the brake lines revealed numerous fractures / crimping which would restrict flow of the brake fluid and so the decision was taken to systematically replace all the brake lines. All in all the brakes turned out to be a costly exercise.

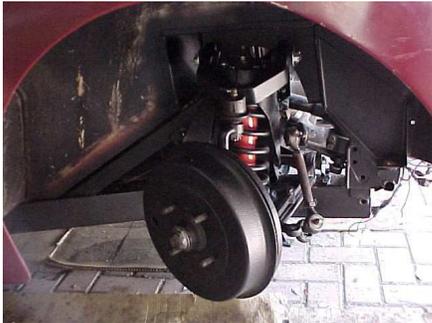
It was at this point that my initial plan of action started to go wrong. Stripping the right front suspension revealed that the car had been in a far more serious front end collision than I had thought, bending the chassis and drastically distorting the vertical link. Some

repairs had been done to the suspension to get the car going though they did not install confidence in me. Again I was extremely lucky to obtain a second hand vertical link as the damaged one was unserviceable, and another trunnion had to be obtained from Harry Fairley. Although I was not comfortable with the state of the right front suspension I nevertheless reassembled it with a view to reassessing the situation once the car was running. Mistake!!

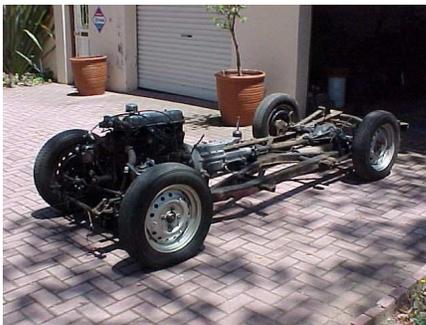
While the body was with Bennie the plan was to clean, paint and tidy up the chassis ready to receive the restored shell. However a closer inspection revealed that the right front suspension had been more severely damaged than I

had originally thought, and with the body removed it could clearly be seen that the fulcrum pins for the lower "A" arms were badly bent.

The fulcrum pins for both right and left lower A arms had to be straightened and the

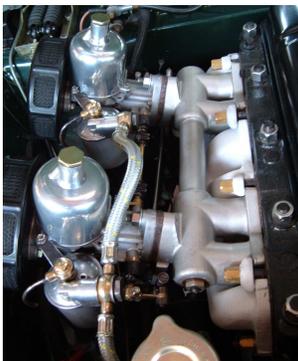
#### CARBURETTORS

Although the car had started easily and idled relatively smoothly, I was concerned at the poor condition of the carburetors and so contacted Riener Holtsberg, (an expert on S.U.'s), for advice. Riener confirmed that they had been severely butchered, requiring extensive repairs, and agreed to take on this task, but the worsening of the exchange rate following the world trade center attacks, resulted in this being an expensive exercise. However the final result was stunning with the carbs. coming back already set up and mounted on a piece Oak, all bright and shiny with polished brass and aluminum looking better than new.

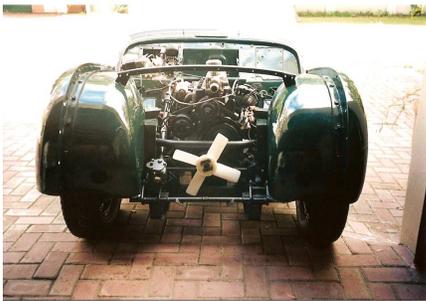
## FAN

The original metal fan was damaged to the extent that one of the four blades was broken off and I was advised that as a modification it was common in any event to replace the original steel fan, which was not very efficient, with a nylon one as used on a Nissan 1400 bakkie. This I duly did and found that it was incredibly cheap and only required minor adaptations to the positioning of the fixing bolt holes and enlarging the center crank hole.

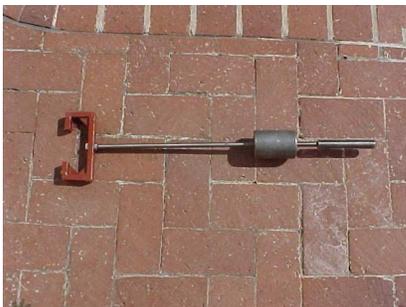
## SIDESHAFTS

On getting the car home and on stands in the garage again I proceeded to strip down the rear axel and soon came to a stand still as I could not extract the side shafts. After trying everything I could think of Igie lent me a sliding hammer to try. I did not have a fixing bracket to fit to the wheel studs and so I had to have one made up at B.A. Engineering, and decided at the same time to get my own sliding hammer made, a beefed up version of Igie's one. The tool manufactured was a bit
