# There 's a Triumph on my Stoep

(Rebuild 1955 Triumph TR2 TS 6766 - O)

David Patten  
March 2007

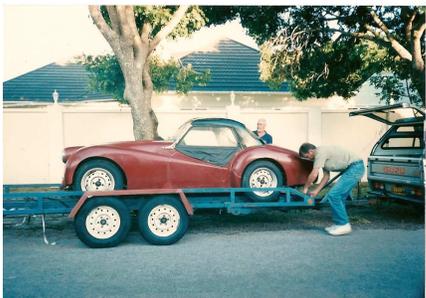
After standing for over 10 years the rear brakes had seized and we could not move the vehicle. The rear wheels were removed and the brakes slackened off but to no avail. After spraying Q 20 into the drums and rotating them with a tyre lever placed between the wheel nuts we eventually released the brakes to a degree. This enabled the car to be moved, but not without considerable effort. It took Pete, Rob, his son, the gardener and I, all our strength to push the

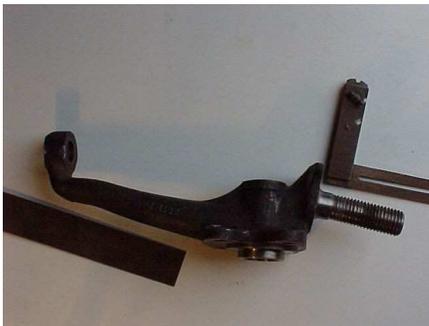
We tackled the left front first so as to keep the right front intact as a guide for reassembly. Once this was stripped it was noticed that in addition to all the bushes being worn the brass trunion also had excessive wear and required replacement. Fortunately I was able to obtain a new one from Harry Fairley. The new trunion however came fitted with a new pivot pin for the lower wishbone that required reaming of the

new bush to fit. This incidentally also resulted in a run around, as there are now only a few engineering works that possess imperial reamers let alone one the size required. Eventually I came across B.A. Engineering in Korsten who were able to do the job.

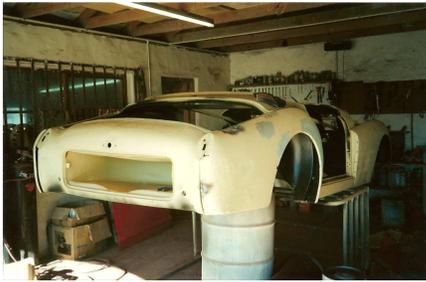
set of both inner and outer sills from Bruce for use as a template to have new ones made in galvanized steel. The striker plate section from the left door post as well as the leading tip of the left front fender had been damaged beyond repair. I was again fortunate in obtaining these replacements from Frikkie Viljoen, who had a donor body for his restoration project and did not require these sections. Once the extensive

welding, panel replacement and brazing was completed it was decided to sandblast the entire car down to bare metal and start from scratch. Again the body was loaded on a large hired trailer and transported to the sandblasters, to be returned a day later in shinning

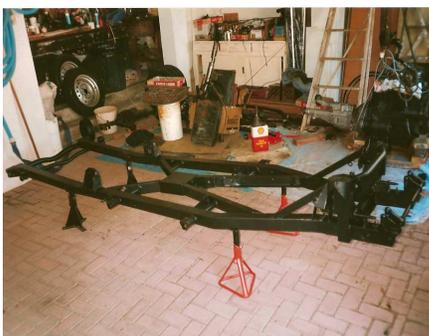
On returning the chassis a week later Dave confirmed that the car had been in a few major altercations, one at the right front, one at the left front, one on the right side and one up the rear!!

radiator mountings repaired. The front fixing pin for the right side leaf spring was straightened and the right front chassis section at the wheel repaired. Numerous other minor repairs to the chassis were also effected at the same time. The chassis was now true and in accordance with original factory specifications. I was delighted as this now gave me a sound base from which to start the assembly process. However I was amazed at the abuse this poor car must have gone through during the course of its life. The extent of

The fulcrum pins for both right and left lower A arms had to be straightened and the

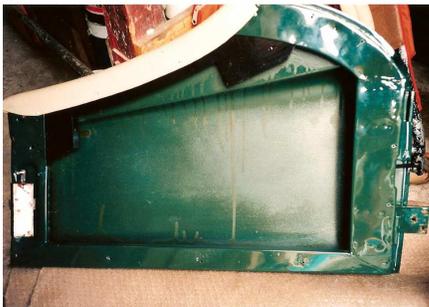
## DOORS

Before fitting the doors the timber inserts supporting the side screen brackets had to first be restored as they were riddled with old screw holes, which were filled and sanded

before painting. When fitting the door latches, as a touch of nostalgia, I left one still painted in "Old English White" to bear witness to the cars original colour, the only trace still remaining on the car.

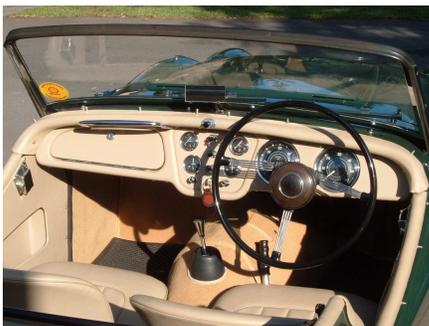
## DASHBOARD AND GAUGES

The loose trim items were completed and brought home as I needed to fit the dashboard. The other items could be installed later, together with the carpets and fitted trim, when

the car was mobile. Before installing the dashboard all the gauges, speedometer and rev counter had to be pulled apart, cleaned, checked and fitted. I was very apprehensive of doing this delicate task as I thought specialist knowledge was required but could not find any such specialist willing to tackle the task, and so had no alternative but to do so myself. I was however given some sound advice from a retired instrument maker, encouraging me to proceed on my own but not

to strip and clean all my gauges without incident, even to the extent of calibrating the temperature gauge by immersing the sensor in boiling water from the kitchen kettle. Fortunately the gauges were all original and intact with no broken or cracked glass, though I did have the bezels re-chromed along with the rear over-riders. The plastic warning and indicator light housings were damaged but I was able to repair these without too much trouble. The timber frame at the edge of the scuttle was also restored, sanded and painted before fitting the dashboard.

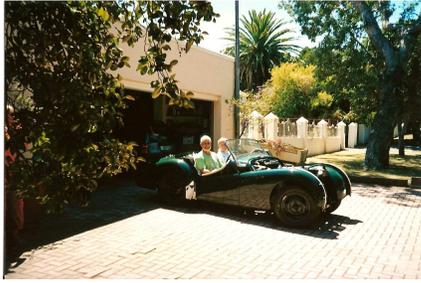
## TEST DRIVE / NOSE CONE AND GRILL

Once the electrics had been sorted out the time came for the first test drive, no nose cone, bonnet or lights etc etc but the car was rolling. This was the moment I had been waiting for as I had never ever driven a TR before, or for that matter ever driven in one.

What had I let myself in for !! The first trip around the block was quite a revelation, motor roaring, suspension as hard as hell, steering a little wandering and brakes, well you have to stand on them, but what a thrill. This really injected new drive into me to get the car completed. The Triumph clubs Nationals were just around the corner and I was determined to have the car ready and attend. The next step was to have the

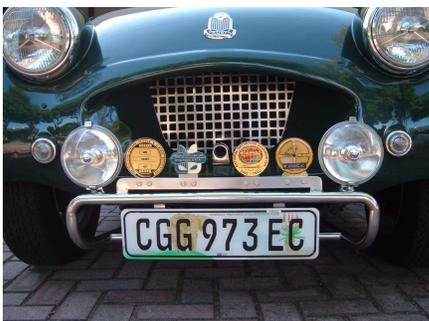
#### BADGE BAR

Unfortunately the one part I have still not been able to source at a reasonable cost is a front bumper, as it seems to have been a past fashion to discard them in the interests of a

more sporty appearance, which was the case with my car. I understand that a Ford Anglia front bumper can be modified to fit with the over-riders inverted, but I was not happy with this compromise. As an alternative I designed a badge bar incorporating a number plate housing and spot light mounting brackets, based on the one I had seen on Bruce's car. A cardboard mock up was made and Stainless Steel Fabrications manufactured the part, which fitted perfectly.

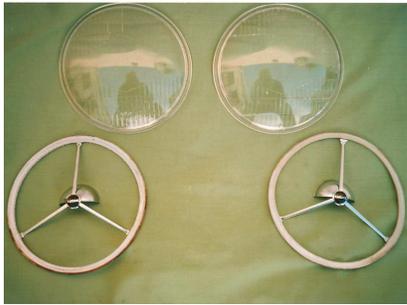
#### HEADLIGHTS

The chrome head light rims were badly damaged from previous accidents and I was able to replace them with good second hand ones from a Mini, which were acquired from Dougie Steyn. The plain sealed beams that were on the car were initially refitted but were

subsequently replaced with two Tripoid units that came as spares. However these units needed the reflectors to be restored, and the only way to achieve this was to carefully grind through the metal retaining rims so as to separate the reflectors from the glass. The reflectors were then re-silvered by Metglo at Brackenfel in the Cape. Reassembly was also tricky as the reflectors had to be glued back to the glass with white silicone. This also served to waterproof the seam, with the fixing

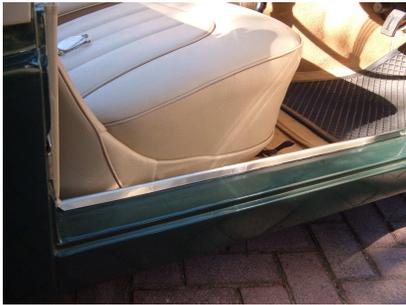
## DOOR SILLS

The original aluminum sills covering the seams on the base of the door aperture were in a very poor condition and Sue was able to source replacement stainless steel ones that were

purpose made by Freezepoint. On hearing what the part was required for, they really went out of their way to help and especially set up their machine to make the complex bend required, charging only a very reasonable price.

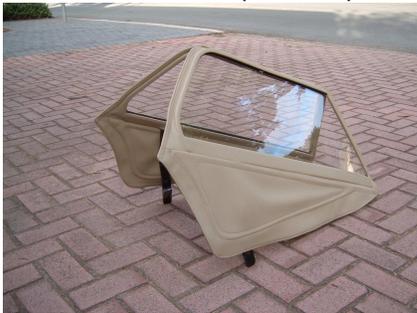
## SIDE SCREENS

covered while the car was prepared for the roadworthy test, a very tight schedule. The original side screens had been modified to have split Perspex windows without the channels being changed to accommodate this and all panels were cracked or very badly scratched, requiring replacement. I decided to revert back to the original solid Perspex style window with a single channel. The screens were covered in the same MB Lex used for the upholstery, hood and tonneau but there was no time to

have new Perspex cut before the Nationals so the original scratched and cracked windows were refitted. These were subsequently replaced with new single piece Perspex, supplied and cut to size by Maizle Plastics in accordance with a cardboard templates I made.

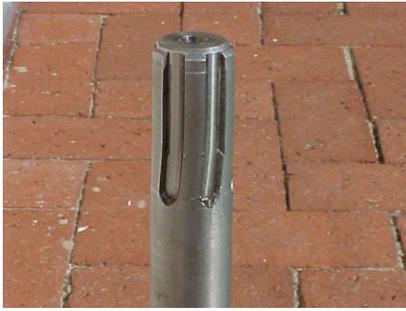
On getting the car home and on stands in the garage again I proceeded to strip down the rear axel and soon came to a stand still as I could not extract the side shafts. After trying everything I could think of Igie lent me a sliding hammer to try. I did not have a fixing bracket to fit to the wheel studs and so I had to have one made up at B.A. Engineering, and decided at the same time to get my own sliding hammer made, a beefed up version of Igie's one. The tool manufactured was a bit

of overkill but it certainly did the trick with one or two wacks.

The right rear bearing was a basket case and I thought it prudent to replace both left and right bearings at the same time so the left side was striped down as well. I was horrified to find that there were two different side shafts in the car with a marked twist in the spline of one of the shafts, at the diff side, caused I am sure by many a hearty wheel spins!!! I was luckily able to replace the damaged side shaft with a second hand unit of the correct specification and purchased the new wheel

bearings and seals off the shelf from Bearingman.

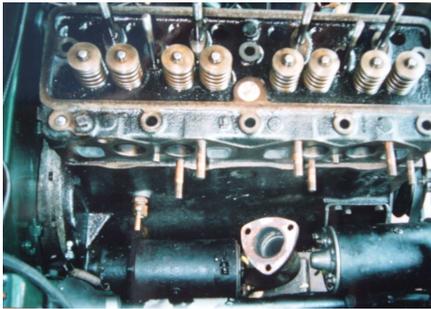
### ENGINE REBUILD

Very soon a disturbing engine noise manifested itself, which started off erratically and soon became a permanent occurrence. I was able to trace the noise to number 1 cylinder and so in search of the problem I started to strip down the head and found a bent pushrod. I was sure that this was the problem and replaced the pushrod with one sourced from the club. Sadly the noise was still there and so I decided that there was no option but to remove the head.

All the nuts were systematically loosened but the head would not come free. I then proceeded to remove all the studs, which came out with remarkable ease apart

from the right rear on number 4 cylinder. With all the other studs out the head could be moved laterally but the stud was turning with the head. I borrowed a stud remover from Frikkie to try and free it but only succeeded in snapping the stud off flush with the head.

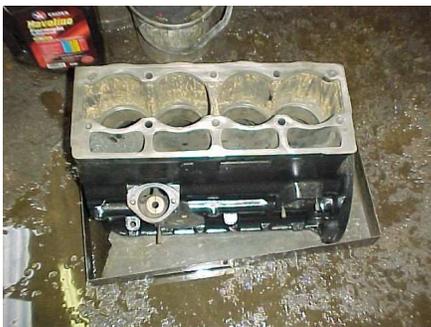
Having gone this far I decided I might as well go the whole hog and fully recon the motor while it was out, so block and head were sent to Nat Potgieter at Master Engines. Nat bored

out the seized stud and stripped the subassembly down to assess the condition. This revealed that there was some wear on the bearings, but the crank was in very good nick, having at some time been cut and hard chromed back to original spec. There was a little wear on the cylinders and it was found that the original 83mm bore loose sleeves had at some stage been replaced with bigger 87mm bore sleeves, increasing the engine capacity from 1991cc to 2193cc. New

pistons, rings and sleeves were available off the shelf from BEPCO, the local Massey Ferguson Tractor agents, in 85mm or 87mm bore so I opted to retain the bigger size, 87mm with its 2193cc capacity. This however necessitated the block having to be machined to fit

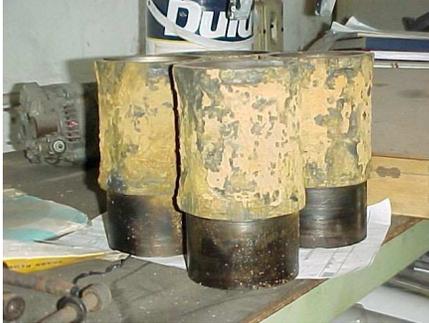
the new sleeves, as for some reason they were slightly bigger externally than the ones being replaced. I also obtained standard main and big end bearings, thrust washers and gasket sets (top and bottom), from BEPCO. Bearing Man made up a new timing chain and an oil pump was purchased from the TSCC. Cam and small end bushes were not available so Nat

manufactured these together with rocker shaft bushes, new head studs, head nuts, a few manifold studs and new brass manifold nuts. The head was skimmed, and the exhaust manifold first refaced before being aluminum metal sprayed by Robbie Deyzel Engineering, who also cut and hard chromed the rocker shaft back to spec as it was badly worn. The valves were ground, new valve guides fitted, the rockers refaced and a new brass Welch Plug made and fitted to the rear of the head.

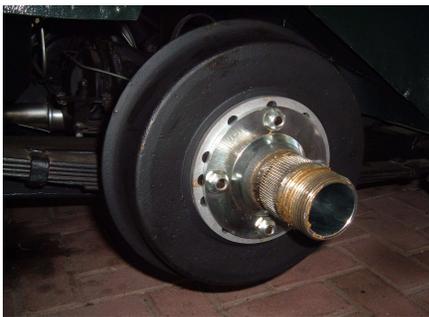
## WHEELS.

The car was now running smoothly with the only real irritation being the out of true steel rims, which produced a vibration at about 100kms per hour, typical of wheel balance

problems. This was tolerated while I waited for the exchange rate to improve. My patience however did not hold out and with a rush of blood to the head I took the plunge and ordered four 60 spoke wire wheels from Moss. I had enquired as to the price of 48, 60 and 72 spoke wheels and decided to go for the 60-spoke option, which was a little less expensive than the 72. Moss however got the order messed up and sent me 72 spoke wheels. They offered to take them back, but with the freight costs I decided to keep them as they are a stronger wheel and have

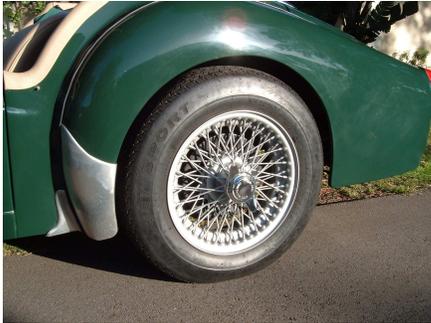
Fitment was by means of bolt on splined hub extension to take the wire wheel and spinner,

which came in a set of four together with special replacement wheel nuts. However the wheel studs are too long and consequently must be shortened by 9mm to take the hub extension. I was not happy with this and instead fitted standard 9mm universal aluminum spacers. They worked like a charm, extending the track and giving the car quite a muscle look by filling the wheel arch. The only down side was that I still had a standard TR2 diff, which I understand is prone to run wheel bearings with the fitment of wider wire

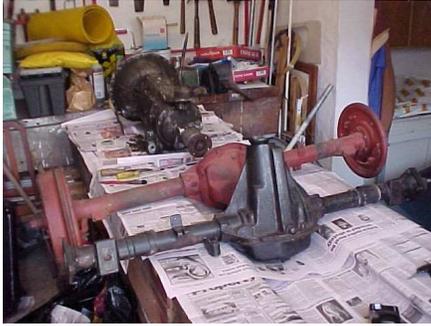
Owen Chandley of Emanuel stripped the gearbox, which revealed that it was a basket case with extensive damage to the main shaft. The gearbox had been acquired from Auto crash, who following Owens chastising provided me with a second box free of charge. This second

gearbox appeared to be seized, but when opened proved serviceable. However Owen sadly passed away before being able to effect the re-conditioning. The gearboxes were recovered and passed on, together with the spare TR3 diff, to Eddie Jansen to recondition.

The diff was tackled first and proved the more costly of the two, requiring new imperial bearings of an unusual size, which were eventually sourced through Eagle Bearings in Commercial Road but were quite expensive.

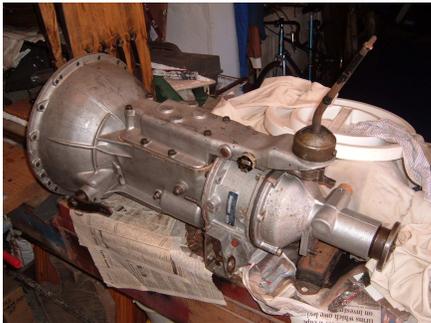
The two gearboxes were stripped and it was found that with the exception of the overdrive unit the components were not compatible. The serviceable gearbox unfortunately had a shorter pilot shaft and Nat Potgieter was accordingly commissioned to manufacture an extension adaptor. Neither the original TR2 clutch plate nor that of a Triumph 2000 could be used due to the difference in spline size and clutch face of the two. After studying the universal clutch manual it was found that a standard clutch plate for a Holden HR series would fit and a new one was purchased off the shelf from Ranger Clutches in Uitenhage.

Both gearboxes were missing solenoids and speedometer drive units. I obtained a solenoid from Charles Mitchell in Bloemfontein, but the speedometer drive and housing was more difficult. I purchased a new speedometer drive gear from Alan Dickens of Super Tune, also in Bloemfontein, but unfortunately he
