# The Madness Continues

Fitting an A type Overdrive Gearbox to a TR2

(including upgrading of electrics)

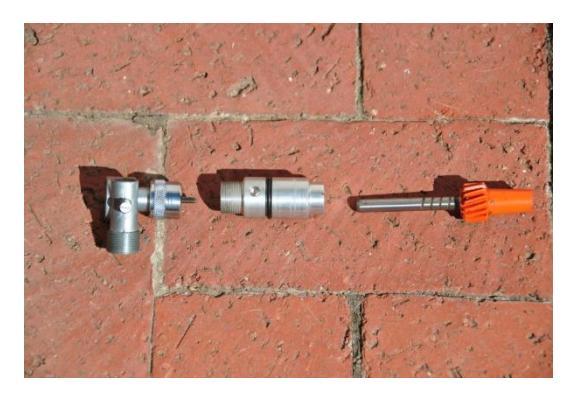
# 2. Solenoid and Speedometer Drive.

I was fortunately able to obtain a second hand solenoid from Charles Mitchell but the speedometer drive and bearing proved more difficult and was ultimately sourced from Moss UK. However without a sample or knowledge of what the speedometer drive and bearing looked like it was difficult to identify the correct part as

there are a few variations. As to be expected the one initially supplied was incorrect and had to be returned. This not only was a bit of a mission but also costly.

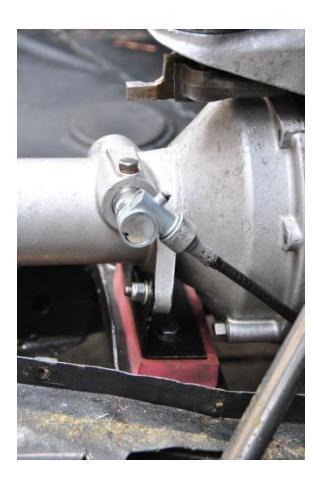
The speedometer cable was connected to the original 4 speed gearbox on the left and came in to the housing at an angle for easy fitment. However in the case of the A type overdrive gearbox the speedometer drive and housing are on the right hand side of the overdrive at a right angle to the drive shaft plane which necessitated the fitment of a 90 degree angle convertor for the speedometer cable. This also could not be sourced locally and had to be imported from Moss UK, again not cheap.
